# Access Compliance Report Public Rights-of-Way (Curb Ramps)

Main Street: COUSTEAU\_LN Cross Street: COUSTEAU\_LN Location: E

ADA ID: RPRK211110140506 Ramp Type: Type 4 - Parallel Initial Pass/Fail: Fail Overall Compliance: No Severity Score: 2

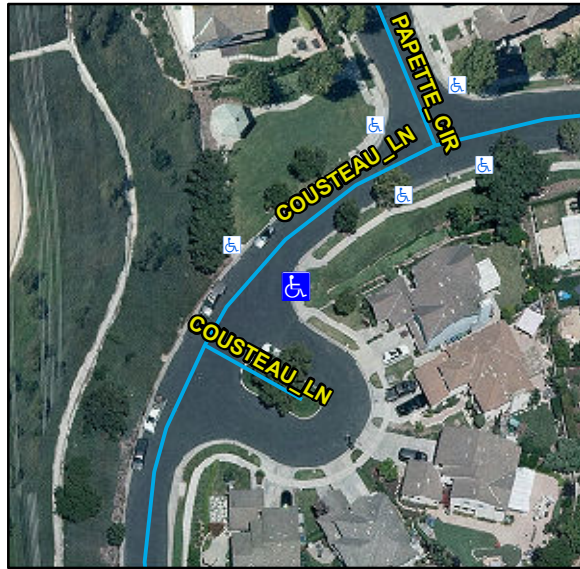
## Field Measurements/Component Compliance

| Compliance | Description | Data | Compliance | Description | Data |
|---|---|---|---|---|---|
| No | Ramp Cross Slope LT (%) | 2.2 | Yes | Ramp Cross Slope RT (%) | 1.7 |
| N/A | Gutter Ponding | N/A | No | Curb Slope | 9.3 |

Remove & Replace Curb Ramp With Two New Directional Ramps or Equivalent.

R304.2.2, R204.3, R304.5.3, STD 1115

Total Cost: \$ 4000
