# Access Compliance Report Public Rights-of-Way (Curb Ramps)

Main Street: COUSTEAU\_LN Cross Street: COUSTEAU\_LN Location: N

ADA ID: RPRK211110140716 Ramp Type: Type 1 - Perpendicular Initial Pass/Fail: Fail Overall Compliance: No Severity Score: 15

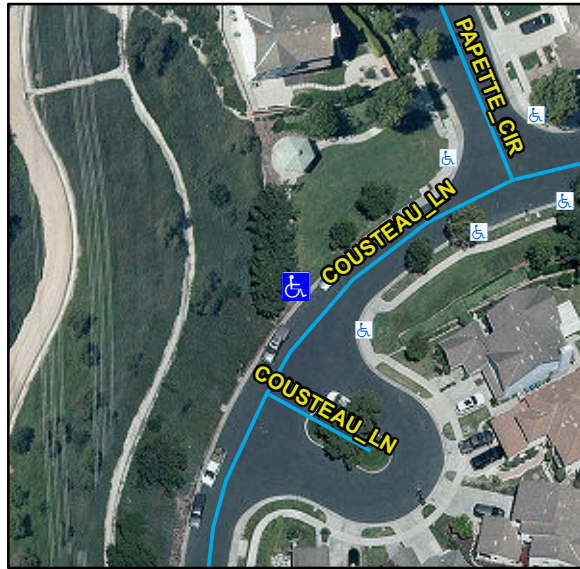
| Compliance | Description | Data | Compliance | Description | Data |
|---|---|---|---|---|---|
| No | Ramp Run Slope (%) | 9 | N/A | Flare Slope LT (%) | N/A |
| No | Gutter Lip Height (in) | 0.25 | | Road Run Slope (%) | N/A |

Remove & Replace Entire Ramp. Grind Gutter Lip.
