# Access Compliance Report Public Rights-of-Way (Curb Ramps)

| Main Street: LA_SALLE_LN | | Cross Street: COUSTEAU_LN | | Location: | SW |
| ADA ID: RPRK211110140923 | Ramp Type: Type 4 - Parallel | Initial Pass/Fail: Fail | Overall Compliance: No | Severity Score: | 32 |

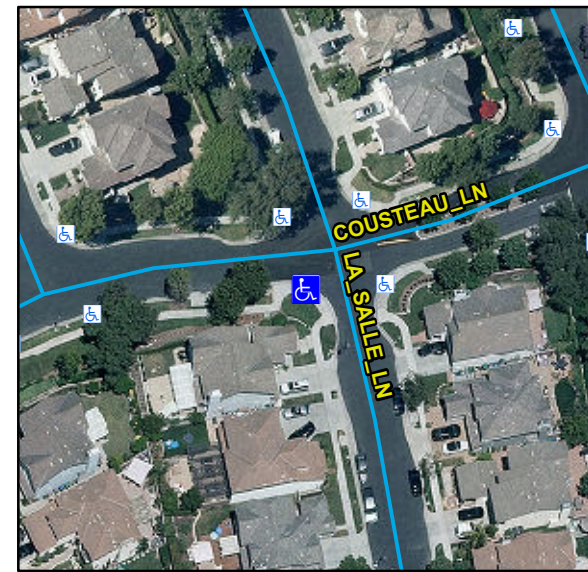
| Compliance | Description | Data | Compliance | Description | Data |
|---|---|---|---|---|---|
| Yes | Ramp Run Slope LT (%) | 1.4 | No | Ramp Run Slope RT (%) | 12.6 |
| No | Ramp Cross Slope LT (%) | 3.1 | Yes | Ramp Cross Slope RT (%) | 1.1 |

**Remove & Replace Curb Ramp With Two New Directional Ramps or Equivalent.**

**R204.3, R304.5.3, R304.3.2, STD 1115**
