# Access Compliance Report Public Rights-of-Way (Curb Ramps)

| Main Street: HYDRANGEA_ST | | Cross Street: O_NEILL_DR | | Location: | NE |
| ADA ID: RPRK211111113410 | Ramp Type: Type 4 - Parallel | Initial Pass/Fail: Fail | Overall Compliance: No | Severity Score: | 32 |

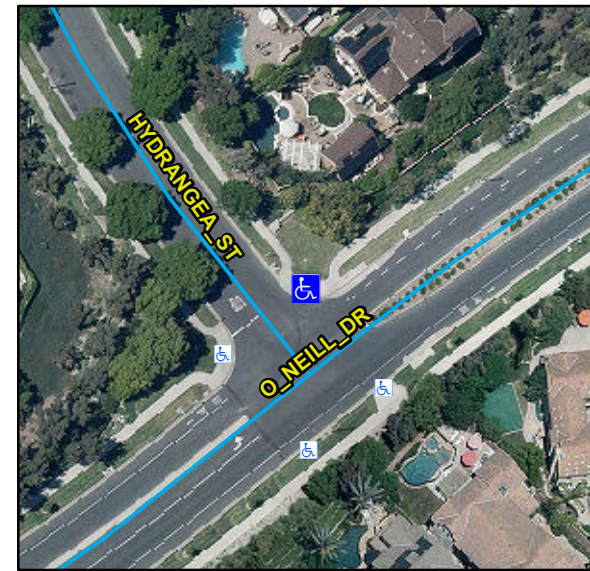
| Compliance | Description | Data | Compliance | Description | Data |
|---|---|---|---|---|---|
| No | Ramp Run Slope LT (%) | 9 | No | Ramp Run Slope RT (%) | 19.6 |
| No | Ramp Cross Slope LT (%) | 4.8 | Yes | Ramp Cross Slope RT (%) | 0.9 |

**Remove & Replace Curb Ramp With Two New Directional Ramps or Equivalent.**

**R204.3, R304.3.2, R304.5.3, STD 1115**
