# Access Compliance Report Public Rights-of-Way (Curb Ramps)

Main Street: O\_NEILL\_DR Cross Street: HYDRANGEA\_ST Location: SE

ADA ID: RPRK211111113655 Ramp Type: Type 1 - Perpendicular Initial Pass/Fail: Pass Overall Compliance: No Severity Score: 50

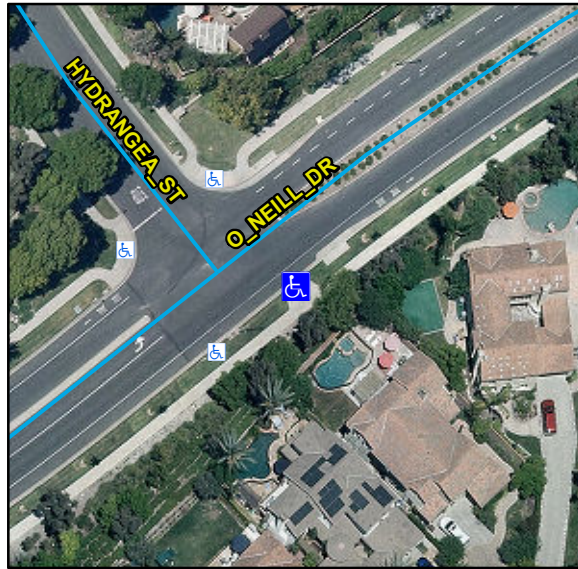
| Compliance | Description | Data | Compliance | Description | Data |
|---|---|---|---|---|---|
| No | Ramp Cross Slope (%) | 7.4 | N/A | Flare Traversable LT | No |
| No | Landing Run Slope (%) | 2.8 | N/A | Flare Traversable RT | No |
| No | Landing Cross Slope (%) | 6.7 | No | DWS Provided | No |
| Yes | Gutter Ponding | No | No | Curb Slope | 14.4 |
| No | Gutter Run Slope (%) | 9.3 | | Road Cross Slope (%) | N/A |
| No | Gutter Cross Slope (%) | 8.8 | | | |

Remove & Replace Entire Ramp. Remove & Replace Gutter.
