# Access Compliance Report Public Rights-of-Way (Curb Ramps)

| Main Street: O_NEILL_DR | | Cross Street: HYDRANGEA_ST | | Location: | NW |
| ADA ID: RPRK211111113940 | Ramp Type: Type 4 - Parallel | Initial Pass/Fail: Fail | Overall Compliance: No | Severity Score: | 15 |

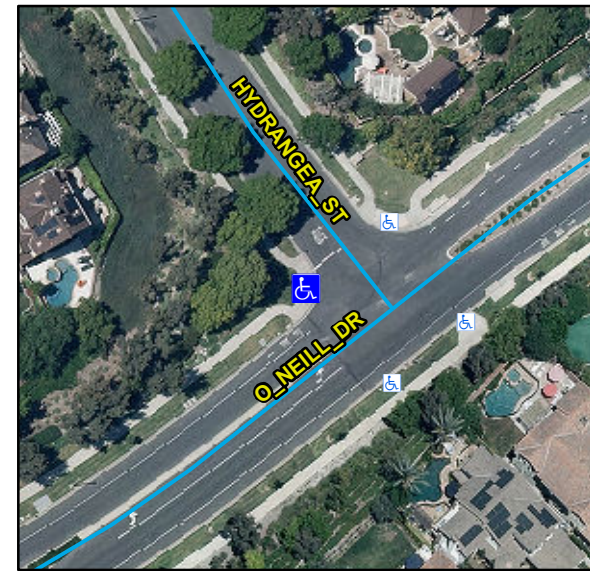
| Compliance | Description | Data | Compliance | Description | Data |
|---|---|---|---|---|---|
| Yes | Ramp Run Slope LT (%) | 3.9 | No | Ramp Run Slope RT (%) | 9.6 |
| N/A | Gutter Ponding | N/A | N/A | Curb Slope | 9.6 |

Possible Solutions:

**Remove & Replace Curb Ramp With Two New Directional Ramps or Equivalent.**

**R204.3, R304.3.2, STD 1115**
