# Access Compliance Report Public Rights-of-Way (Curb Ramps)

| Main Street: SHIVELY_RD | | Cross Street: RANUNCULUS_ST | | Location: | SW |
| ADA ID: RPRK211111114459 | Ramp Type: Type 4 - Parallel | Initial Pass/Fail: Fail | Overall Compliance: No | Severity Score: | 30 |

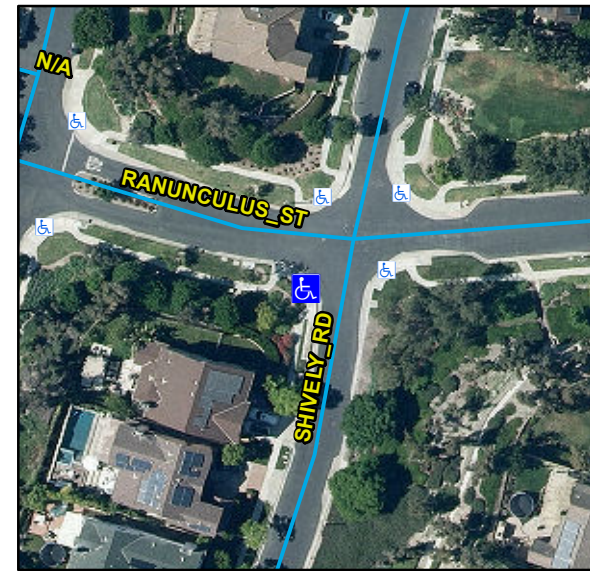
| Compliance | Description | Data | Compliance | Description | Data |
|---|---|---|---|---|---|
| No | Ramp Run Slope LT (%) | 14.7 | Yes | Ramp Run Slope RT (%) | 5.4 |

Possible Solutions:

**Remove & Replace Curb Ramp With Two New Directional Ramps or Equivalent.**

**R204.3, R304.3.2, STD 1115**

Total Cost: \$ 4000
