# Access Compliance Report Public Rights-of-Way (Curb Ramps)

| Main Street: RANUNCULUS_ST | | Cross Street: SHIVELY_RD | | Location: | S |
| ADA ID: RPRK211111114649 | Ramp Type: Type 4 - Parallel | Initial Pass/Fail: Fail | Overall Compliance: No | Severity Score: | 30 |

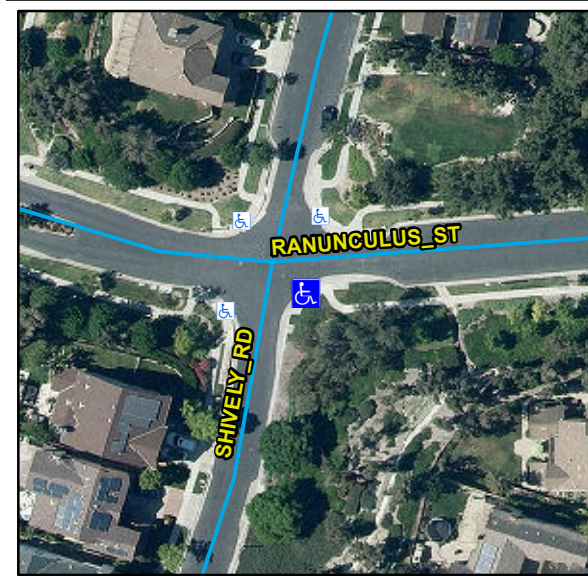
| Compliance | Description | Data | Compliance | Description | Data |
|---|---|---|---|---|---|
| No | Ramp Run Slope LT (%) | 13.4 | Yes | Ramp Run Slope RT (%) | 0.3 |

Possible Solutions:

**Remove & Replace Curb Ramp With Two New Directional Ramps or Equivalent.**

**R204.3, R304.3.2, STD 1115**
