# Access Compliance Report Public Rights-of-Way (Curb Ramps)

Main Street: LANGFORD\_RD Cross Street: RANUNCULUS\_ST Location: W

ADA ID: RPRK211111114918 Ramp Type: Type 4 - Parallel Initial Pass/Fail: Fail Overall Compliance: No Severity Score: 30

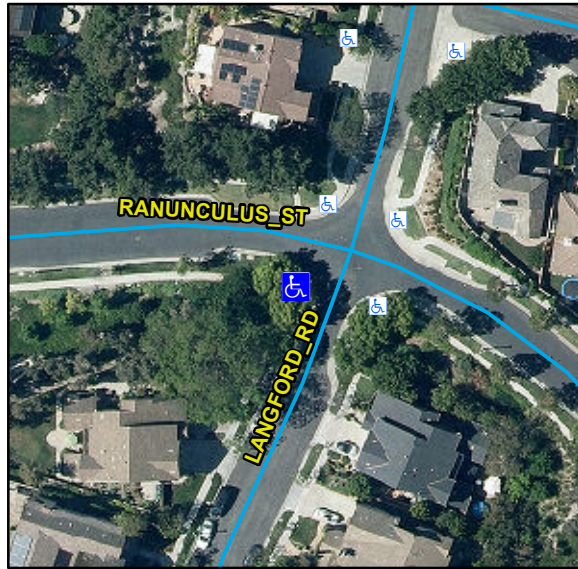
| Compliance | Description | Data | Compliance | Description | Data |
|---|---|---|---|---|---|
| No | Ramp Run Slope LT (%) | 16.5 | No | Ramp Run Slope RT (%) | 8.6 |

Remove & Replace Curb Ramp With Two New Directional Ramps or Equivalent.

R204.3, R304.3.2, STD 1115
