# Access Compliance Report Public Rights-of-Way (Curb Ramps)

| Main Street: RANUNCULUS_ST | | Cross Street: LANGFORD_RD | | Location: | S |
| ADA ID: RPRK211111115130 | Ramp Type: Type 4 - Parallel | Initial Pass/Fail: Fail | Overall Compliance: No | Severity Score: | 30 |

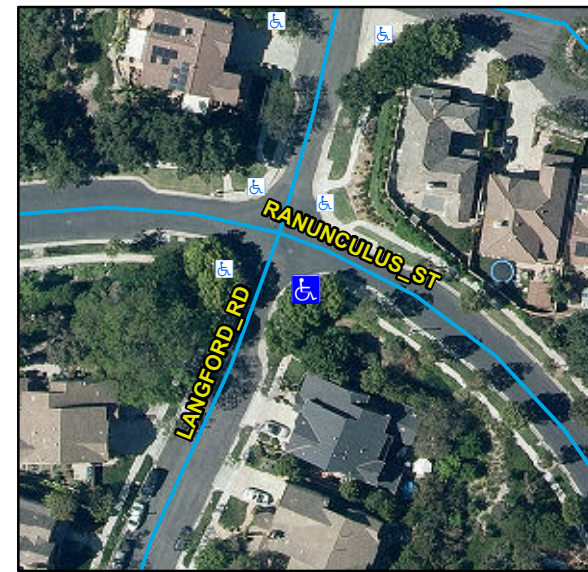
| Compliance | Description | Data | Compliance | Description | Data |
|---|---|---|---|---|---|
| No | Ramp Run Slope LT (%) | 14.9 | Yes | Ramp Run Slope RT (%) | 2.1 |

**Remove & Replace Curb Ramp With Two New Directional Ramps or Equivalent.**

**R204.3, R304.3.2, STD 1115**

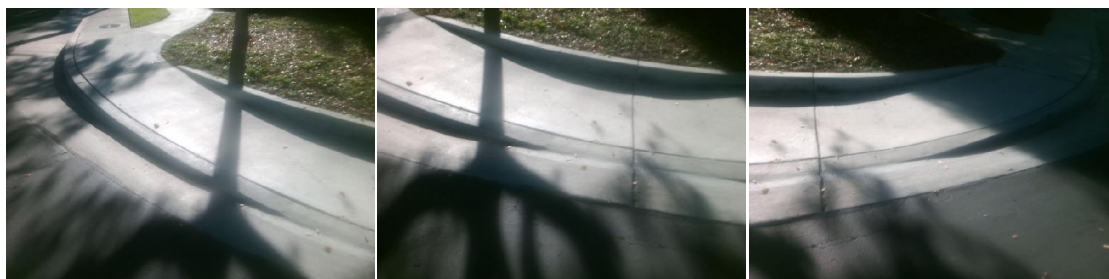
| Compliance | Description | Data | Compliance | Description | Data |
|---|---|---|---|---|---|
| N/A | Ramp Length LT (in) | 136 | N/A | Ramp Length RT (in) | 139 |
| Yes | Ramp Width LT (in) | 53 | Yes | Ramp Width RT (in) | 53 |
| Yes | Ramp Cross Slope LT (%) | 1.4 | Yes | Ramp Cross Slope RT (%) | 1.3 |
