# Access Compliance Report Public Rights-of-Way (Curb Ramps)

Main Street: LANGFORD\_RD Cross Street: RANUNCULUS\_ST Location: E

ADA ID: RPRK211111115326 Ramp Type: Type 4 - Parallel Initial Pass/Fail: Fail Overall Compliance: No Severity Score: 32

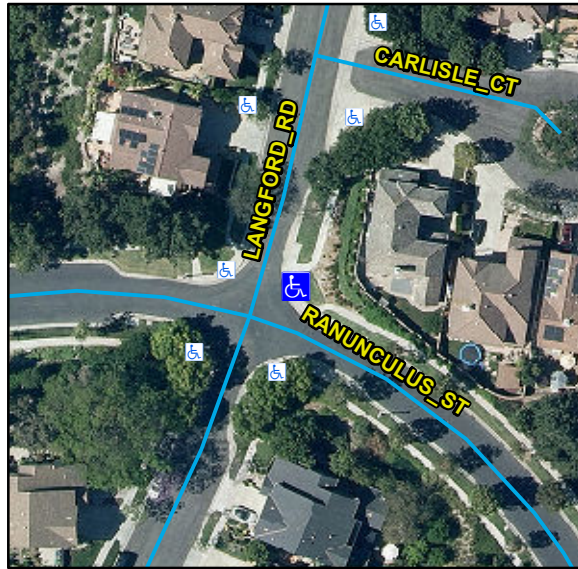
| Compliance | Description | Data | Compliance | Description | Data |
|---|---|---|---|---|---|
| Yes | Ramp Run Slope LT (%) | 1.3 | No | Ramp Run Slope RT (%) | 15.5 |
| No | Ramp Cross Slope LT (%) | 2.4 | Yes | Ramp Cross Slope RT (%) | 2 |

Remove & Replace Curb Ramp With Two New Directional Ramps or Equivalent.
