# Access Compliance Report Public Rights-of-Way (Curb Ramps)

| Main Street: LANGFORD_RD | | Cross Street: CARLISLE_CT | | Location: | E |
| ADA ID: RPRK211111115731 | Ramp Type: Type 4 - Parallel | Initial Pass/Fail: Fail | Overall Compliance: No | Severity Score: | 16 |

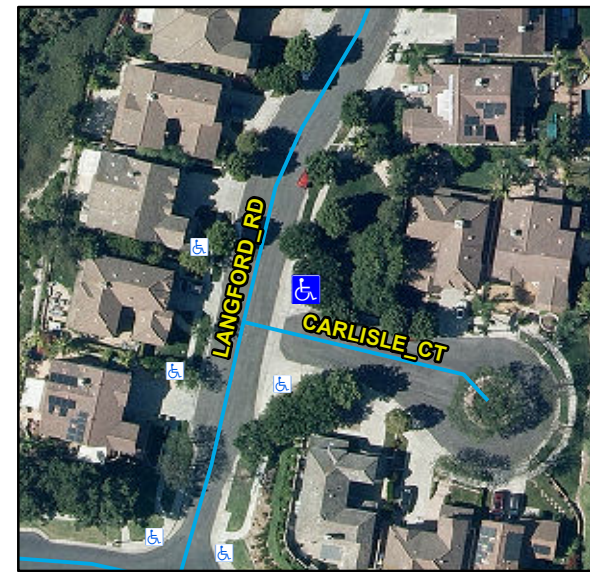
| Compliance | Description | Data | Compliance | Description | Data |
|---|---|---|---|---|---|
| No | Ramp Run Slope LT (%) | 9.7 | Yes | Ramp Run Slope RT (%) | 4.2 |
| No | Ramp Cross Slope LT (%) | 2.5 | No | Ramp Cross Slope RT (%) | 2.4 |

Possible Solutions:

**Remove & Replace Curb Ramp With Two New Directional Ramps or Equivalent.**

**R204.3, R304.3.2, R304.5.3, STD 1115**

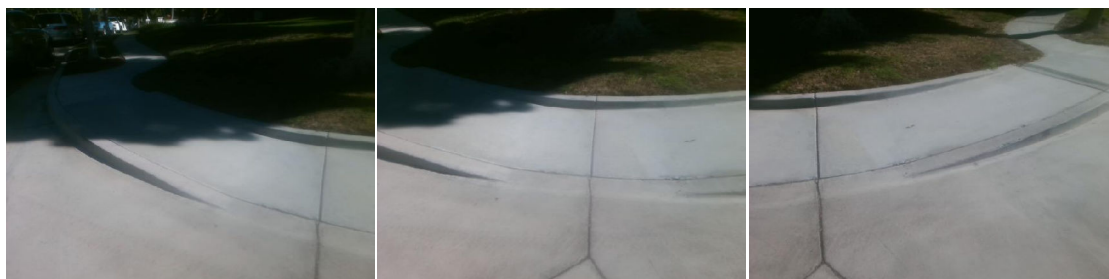
| Compliance | Description | Data | Compliance | Description | Data |
|---|---|---|---|---|---|
| N/A | Ramp Length LT (in) | 138 | N/A | Ramp Length RT (in) | 141 |
| Yes | Ramp Width LT (in) | 53 | Yes | Ramp Width RT (in) | 53 |
