# Access Compliance Report Public Rights-of-Way (Curb Ramps)

Main Street: RANUNCULUS\_ST Cross Street: LANGFORD\_RD Location: N

ADA ID: RPRK211111120022 Ramp Type: Type 4 - Parallel Initial Pass/Fail: Fail Overall Compliance: No Severity Score: 32

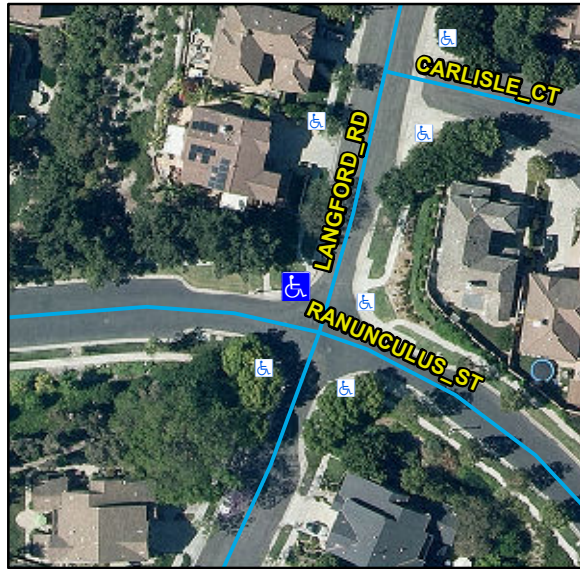
| Compliance | Description | Data | Compliance | Description | Data |
|---|---|---|---|---|---|
| Yes | Ramp Run Slope LT (%) | 6.6 | No | Ramp Run Slope RT (%) | 14.7 |
| Yes | Ramp Cross Slope LT (%) | 1.8 | No | Ramp Cross Slope RT (%) | 2.3 |

Remove & Replace Curb Ramp With Two New Directional Ramps or Equivalent.
