# Access Compliance Report Public Rights-of-Way (Curb Ramps)

| Main Street: RANUNCULUS_ST | | Cross Street: SHIVELY_RD | | Location: | N |
| ADA ID: RPRK211111120532 | Ramp Type: Type 4 - Parallel | Initial Pass/Fail: Fail | Overall Compliance: No | Severity Score: | 32 |

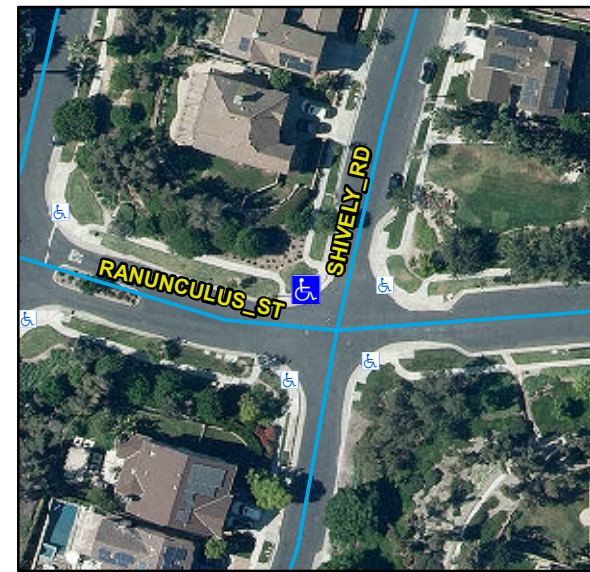
| Compliance | Description | Data | Compliance | Description | Data |
|---|---|---|---|---|---|
| Yes | Ramp Run Slope LT (%) | 7.6 | No | Ramp Run Slope RT (%) | 17.9 |
| No | Ramp Cross Slope LT (%) | 4.6 | Yes | Ramp Cross Slope RT (%) | 0.4 |

**Remove & Replace Curb Ramp With Two New Directional Ramps or Equivalent.**

**R204.3, R304.5.3, R304.3.2, STD 1115**
