# Access Compliance Report Public Rights-of-Way (Curb Ramps)

| Main Street: TUBEROSE_ST | | Cross Street: AGAPANTHUS_ST | | Location: | SW |
| ADA ID: RPRK211111121616 | Ramp Type: Type 4 - Parallel | Initial Pass/Fail: Fail | Overall Compliance: No | Severity Score: | 16 |

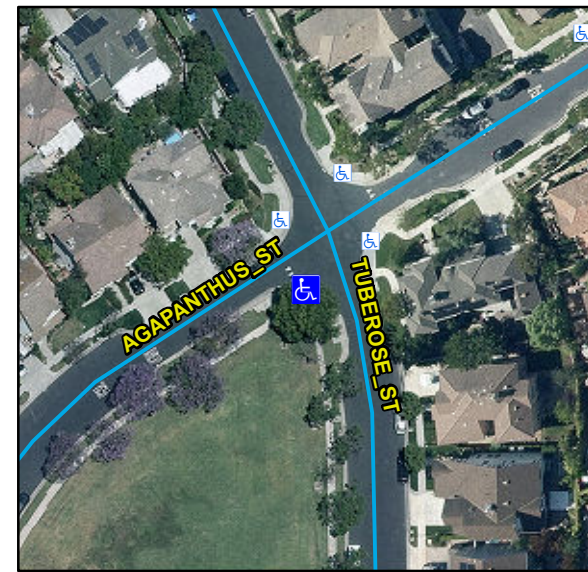
| Compliance | Description | Data | Compliance | Description | Data |
|---|---|---|---|---|---|
| No | Ramp Run Slope LT (%) | 9.4 | Yes | Ramp Run Slope RT (%) | 4.4 |
| Yes | Ramp Cross Slope LT (%) | 1.3 | No | Ramp Cross Slope RT (%) | 2.9 |

**Remove & Replace Curb Ramp With Two New Directional Ramps or Equivalent.**

**R204.3, R304.3.2, R304.5.3, STD 1115**

Total Cost: \$ 4000

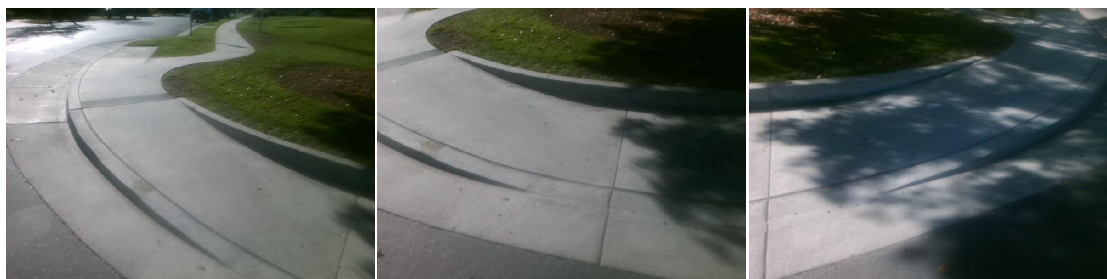
| Compliance | Description | Data | Compliance | Description | Data |
|---|---|---|---|---|---|
| N/A | Ramp Length LT (in) | 132 | N/A | Ramp Length RT (in) | 132 |
| Yes | Ramp Width LT (in) | 54 | Yes | Ramp Width RT (in) | 54 |
