# Access Compliance Report Public Rights-of-Way (Curb Ramps)

| Main Street: AGAPANTHUS_ST | | Cross Street: TUBEROSE_ST | | Location: | SE |
| ADA ID: RPRK211111121822 | Ramp Type: Type 4 - Parallel | Initial Pass/Fail: Pass | Overall Compliance: No | Severity Score: | 25 |

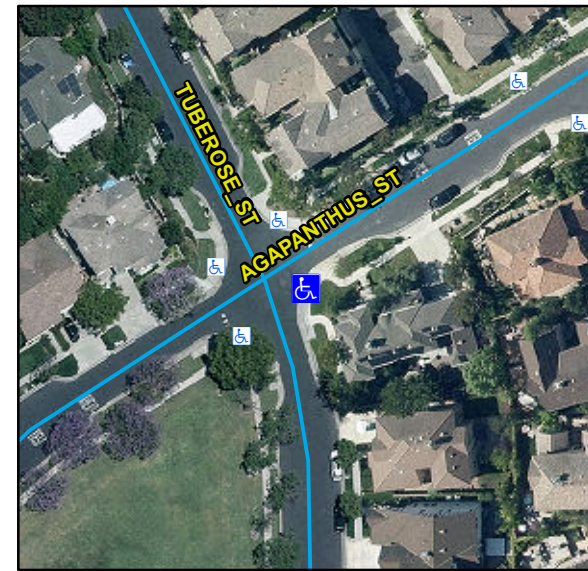
| Compliance | Description | Data | Compliance | Description | Data |
|---|---|---|---|---|---|
| Yes | Ramp Run Slope LT (%) | 2.8 | Yes | Ramp Run Slope RT (%) | 7.4 |
| N/A | Landing Present | No | No | DWS Provided | No |
| No | Landing Width (in) | N/A | N/A | DWS Length (in) | N/A |
| No | Landing Run Slope (%) | N/A | N/A | DWS Full Width | N/A |
| No | Landing Cross Slope (%) | N/A | | DWS Offset Type | N/A |
| No | Gutter Run Slope (%) | 12.6 | | Road Cross Slope (%) | 2.1 |

Possible Solutions:

**Remove & Replace Curb Ramp With Two New Directional Ramps or Equivalent. Remove & Replace Gutter.**

**R204.3, R304.2.1, R304.2.2-Perp, R304.3.2-Para, R304.5.3, R305, R304.5.4, STD 1115**

Total Cost: \$ 4252

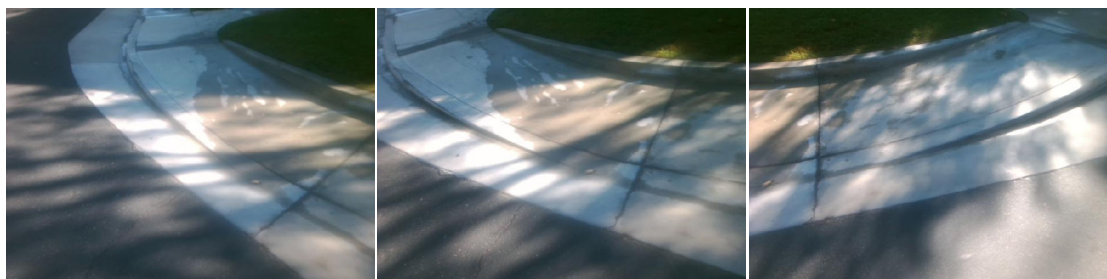
| Compliance | Description | Data | Compliance | Description | Data |
|---|---|---|---|---|---|
| Yes | Obstructions Present? | No | N/A | Utilities Present? | No |
| | Obstruction Types | N/A | | Utility Types | |
| | Obstruction Dimensions | N/A | | | N/A |
