# Access Compliance Report Public Rights-of-Way (Curb Ramps)

| Main Street: AGAPANTHUS_ST | | Cross Street: AGAPANTHUS_ST | | Location: | N |
| ADA ID: RPRK211111122725 | Ramp Type: Type 4 - Parallel | Initial Pass/Fail: Pass | Overall Compliance: No | Severity Score: | 25 |

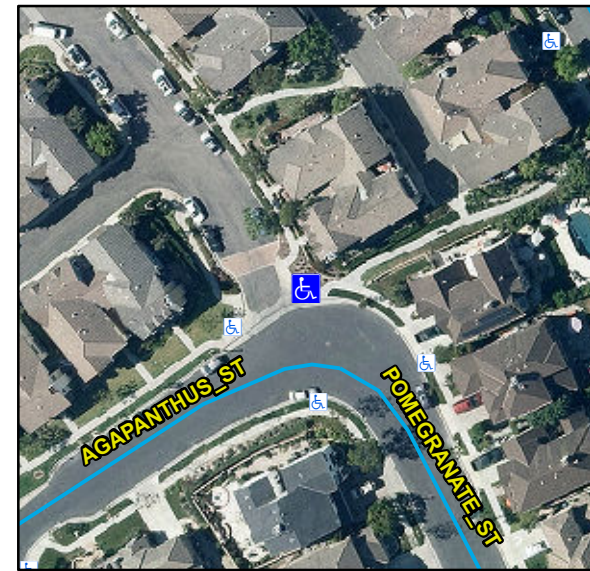
| Compliance | Description | Data | Compliance | Description | Data |
|---|---|---|---|---|---|
| N/A | Landing Present | No | No | DWS Provided | No |
| No | Landing Width (in) | N/A | N/A | DWS Length (in) | N/A |
| No | Landing Run Slope (%) | N/A | N/A | DWS Full Width | N/A |
| No | Landing Cross Slope (%) | N/A | | DWS Offset Type | N/A |
| Yes | Gutter Ponding | No | No | Curb Slope | 9.3 |
| No | Gutter Run Slope (%) | 6.8 | | Road Cross Slope (%) | 5.6 |
| No | Gutter Cross Slope (%) | 3.1 | No | Perpendicular Joint Present | No |

**Remove & Replace Curb Ramp With Two New Directional Ramps or Equivalent. Remove & Replace Gutter.**
