# Access Compliance Report Public Rights-of-Way (Curb Ramps)

| Main Street: AGAPANTHUS_ST | | Cross Street: AGAPANTHUS_ST | | Location: | N |
| ADA ID: RPRK211111122923 | Ramp Type: Type 4 - Parallel | Initial Pass/Fail: Pass | Overall Compliance: No | Severity Score: | 20 |

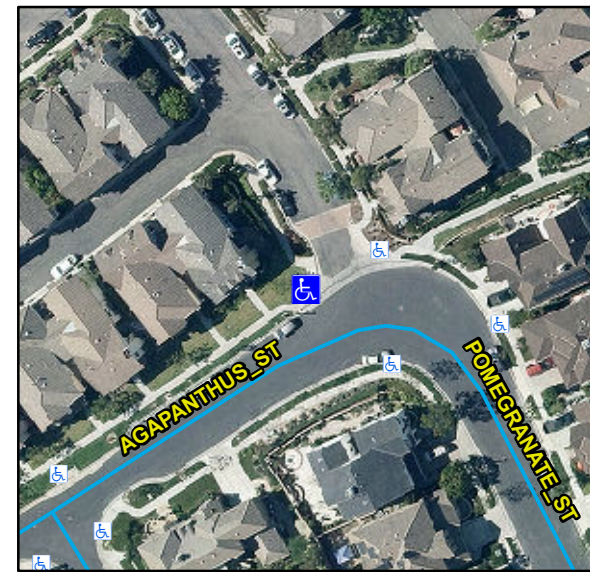
| Compliance | Description | Data | Compliance | Description | Data |
|---|---|---|---|---|---|
| N/A | Landing Present | No | No | DWS Provided | No |
| No | Landing Width (in) | N/A | N/A | DWS Length (in) | N/A |
| No | Landing Run Slope (%) | N/A | N/A | DWS Full Width | N/A |
| No | Landing Cross Slope (%) | N/A | | DWS Offset Type | N/A |

**Remove & Replace Curb Ramp With Two New Directional Ramps or Equivalent.**

**R204.3, R304.2.1, R304.2.2-Perp, R304.3.2-Para, R304.5.3, R305, STD 1115**

Total Cost: \$ 4000
