# Access Compliance Report Public Rights-of-Way (Curb Ramps)

Main Street: TUBEROSE\_ST Cross Street: AGAPANTHUS\_ST Location: NE

ADA ID: RPRK211111123146 Ramp Type: Type 4 - Parallel Initial Pass/Fail: Pass Overall Compliance: No Severity Score: 26

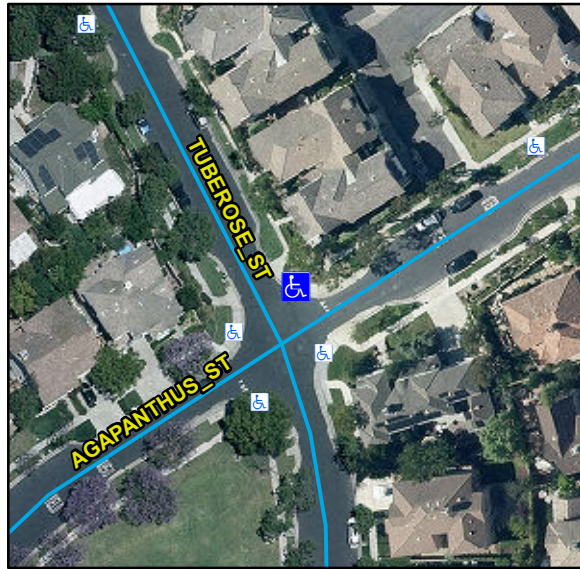
| Compliance | Description | Data | Compliance | Description | Data |
|---|---|---|---|---|---|
| No | Ramp Cross Slope LT (%) | 2.3 | No | Ramp Cross Slope RT (%) | 2.4 |
| No | Gutter Run Slope (%) | 9.8 | | Road Cross Slope (%) | 4.8 |

Remove & Replace Curb Ramp With Two New Directional Ramps or Equivalent. Remove & Replace Gutter.

R204.3, R304.5.3, R304.2.1, R304.2.2-Perp, R304.3.2-Para, R305, R304.5.4, STD 1115
