# Access Compliance Report Public Rights-of-Way (Curb Ramps)

| Main Street: AGAPANTHUS_ST | | Cross Street: TUBEROSE_ST | | Location: | NW |
| ADA ID: RPRK211111123519 | Ramp Type: Type 4 - Parallel | Initial Pass/Fail: Fail | Overall Compliance: No | Severity Score: | 16 |

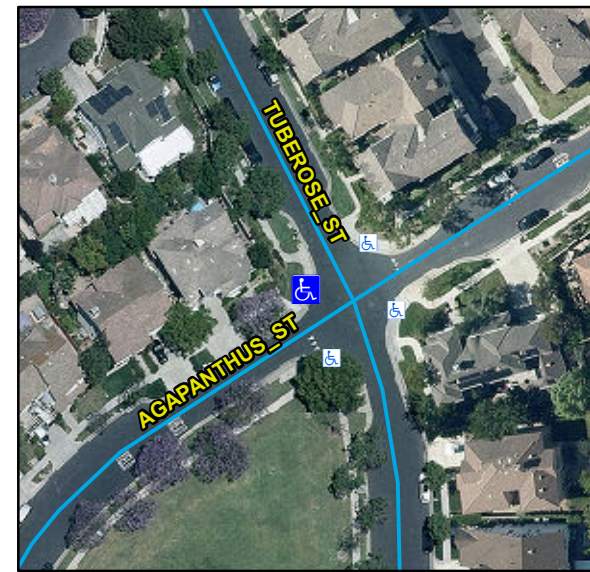
| Compliance | Description | Data | Compliance | Description | Data |
|---|---|---|---|---|---|
| No | Ramp Run Slope LT (%) | 8.5 | Yes | Ramp Run Slope RT (%) | 3 |
| Yes | Ramp Cross Slope LT (%) | 0.7 | No | Ramp Cross Slope RT (%) | 2.4 |

**Remove & Replace Curb Ramp With Two New Directional Ramps or Equivalent.**

**R204.3, R304.3.2, R304.5.3, STD 1115**

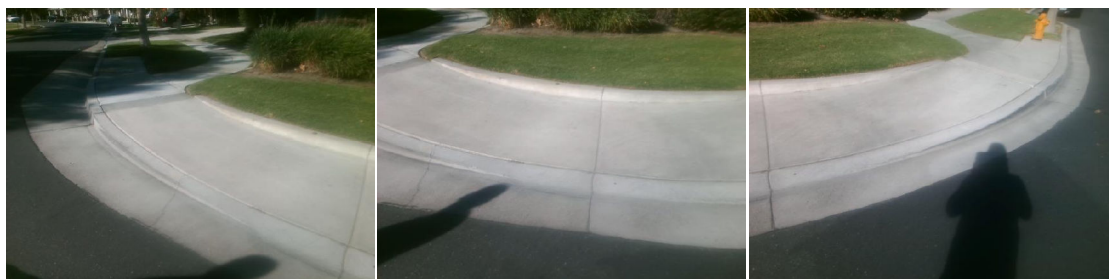
| Compliance | Description | Data | Compliance | Description | Data |
|---|---|---|---|---|---|
| N/A | Ramp Length LT (in) | 134 | N/A | Ramp Length RT (in) | 130 |
| Yes | Ramp Width LT (in) | 58 | Yes | Ramp Width RT (in) | 58 |
