# Access Compliance Report Public Rights-of-Way (Curb Ramps)

| Main Street: SIENNA_PKWY | | Cross Street: O_NEILL_DR | | Location: | SW |
| ADA ID: RPRK211111124430 | Ramp Type: Type 1 - Perpendicular | Initial Pass/Fail: Fail | Overall Compliance: No | Severity Score: | 32 |

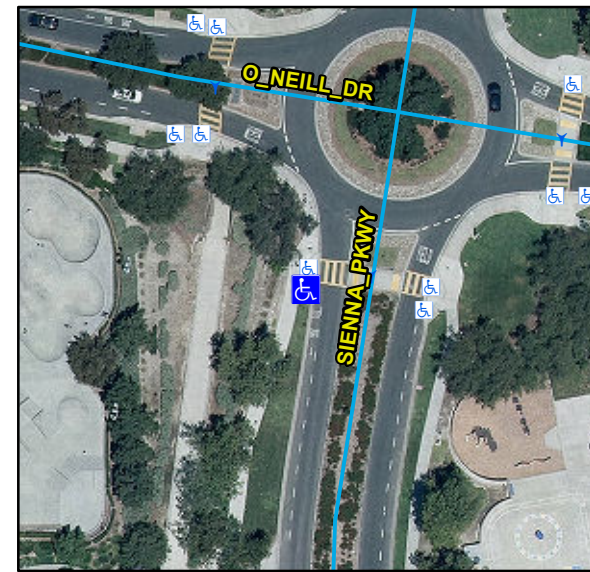
| Compliance | Description | Data | Compliance | Description | Data |
|---|---|---|---|---|---|
| No | Ramp Run Slope (%) | 13.9 | N/A | Flare Slope LT (%) | N/A |
| No | Ramp Cross Slope (%) | 2.6 | N/A | Flare Traversable LT | N/A |

Remove & Replace Entire Ramp.

R204.3, R304.2.2, R304.5.3, STD 1115
