# Access Compliance Report Public Rights-of-Way (Curb Ramps)

Main Street: SIENNA\_PKWY Cross Street: O\_NEILL\_DR Location: SW

ADA ID: RPRK211111124539 Ramp Type: Type 1 - Perpendicular Initial Pass/Fail: Fail Overall Compliance: No Severity Score: 2

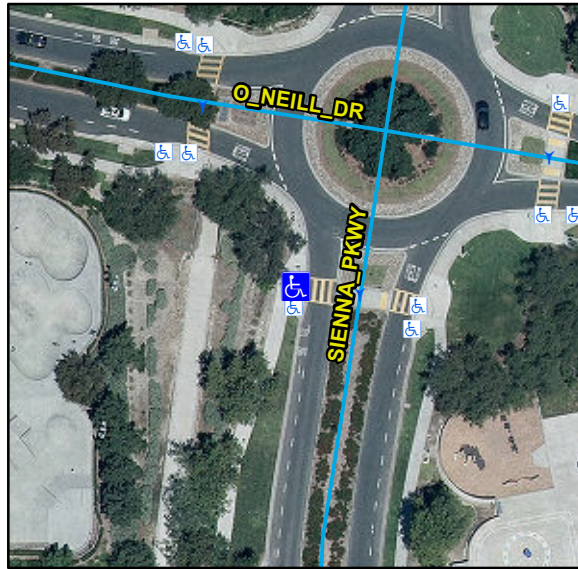
| Compliance | Description | Data | Compliance | Description | Data |
|---|---|---|---|---|---|
| No | Ramp Cross Slope (%) | 3 | N/A | Flare Traversable LT | N/A |
| N/A | Gutter Ponding | N/A | No | Curb Slope | 6.6 |

Remove & Replace Entire Ramp.

R304.2.2, R304.5.3, STD 1115
