# Access Compliance Report Public Rights-of-Way (Curb Ramps)

Main Street: SIENNA\_PKWY Cross Street: O\_NEILL\_DR Location: SW

ADA ID: RPRK211111124936 Ramp Type: Type 1 - Perpendicular Initial Pass/Fail: Pass Overall Compliance: No Severity Score: 0

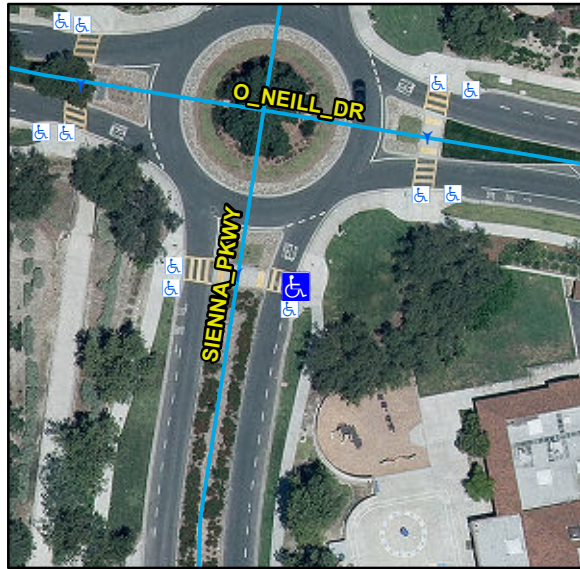
| Compliance | Description | Data | Compliance | Description | Data |
|---|---|---|---|---|---|
| Yes | Gutter Ponding | No | No | Curb Slope | 6.2 |
| No | Gutter Cross Slope (%) | 2.1 | | | |

Remove & Replace Entire Ramp. Remove & Replace Gutter.

R304.2.2, R304.2.3, R304.5.3, STD 1115
