# Access Compliance Report Public Rights-of-Way (Curb Ramps)

| Main Street: SIENNA_PKWY | | Cross Street: O_NEILL_DR | | Location: | SW |
| ADA ID: RPRK211111125137 | Ramp Type: Type 1 - Perpendicular | Initial Pass/Fail: Fail | Overall Compliance: No | Severity Score: | 16 |

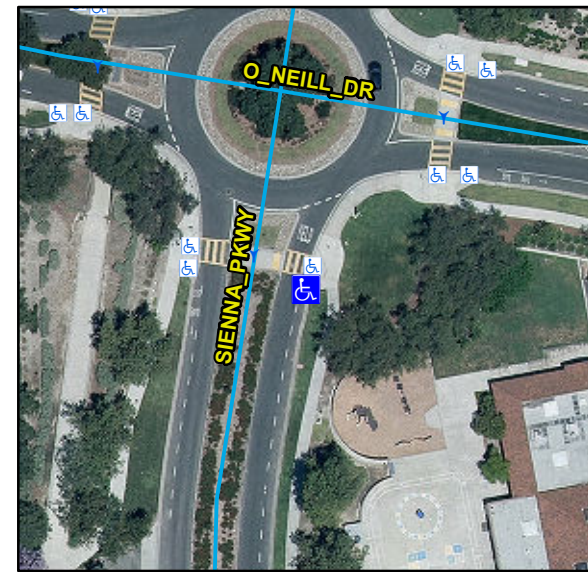
R304.2.2, R204.3, STD 1115

Possible Solutions:

Remove & Replace Entire Ramp.

Total Cost: \$ 3080

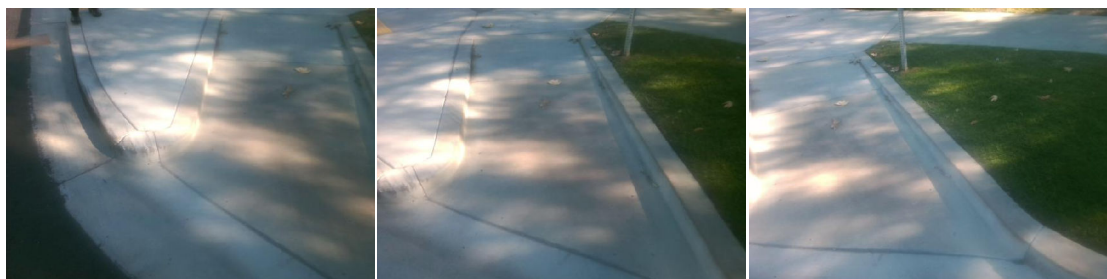
| Compliance | Description | Data | Compliance | Description | Data |
|---|---|---|---|---|---|
| No | Ramp Run Slope (%) | 9.4 | N/A | Flare Slope LT (%) | N/A |
| N/A | Gutter Ponding | N/A | No | Curb Slope | 10.1 |
