# Access Compliance Report Public Rights-of-Way (Curb Ramps)

| Main Street: O_NEILL_DR | | Cross Street: SIENNA_PKWY | | Location: | SE |
| ADA ID: RPRK211111125437 | Ramp Type: Type 1 - Perpendicular | Initial Pass/Fail: Fail | Overall Compliance: No | Severity Score: | 16 |

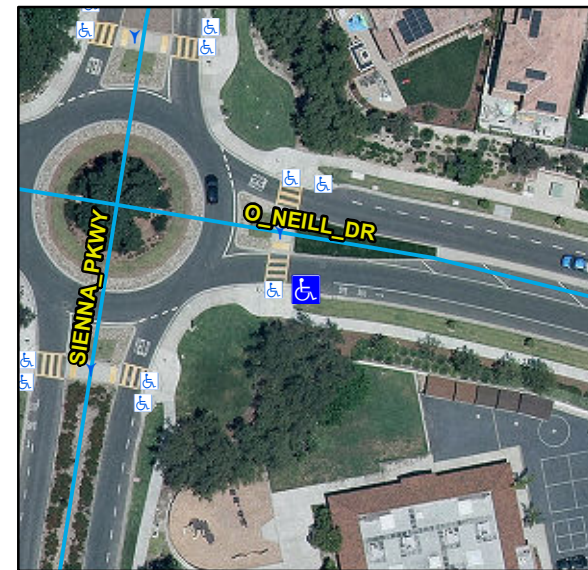
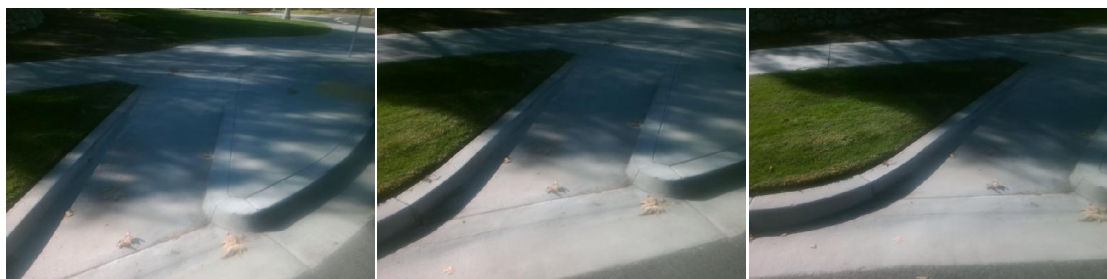
| Compliance | Description | Data | Compliance | Description | Data |
|---|---|---|---|---|---|
| No | Ramp Run Slope (%) | 9.4 | N/A | Flare Slope LT (%) | N/A |
| No | Ramp Cross Slope (%) | 2.9 | N/A | Flare Traversable LT | N/A |

Remove & Replace Entire Ramp.

R204.3, R304.2.2, R304.5.3, STD 1115

Total Cost: \$ 3080
