# Access Compliance Report Public Rights-of-Way (Curb Ramps)

Main Street: O\_NEILL\_DR Cross Street: SIENNA\_PKWY Location: SE

ADA ID: RPRK211111125833 Ramp Type: Type 1 - Perpendicular Initial Pass/Fail: Fail Overall Compliance: No Severity Score: 16

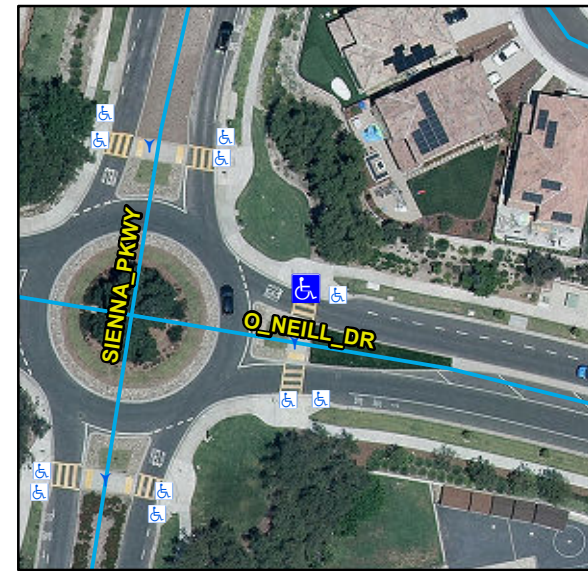
| Compliance | Description | Data | Compliance | Description | Data |
|---|---|---|---|---|---|
| No | Ramp Run Slope (%) | 8.5 | N/A | Flare Slope LT (%) | N/A |
| No | Ramp Cross Slope (%) | 2.7 | N/A | Flare Traversable LT | N/A |

Remove & Replace Entire Ramp.

R304.2.2, R304.5.3, STD 1115
