# Access Compliance Report Public Rights-of-Way (Curb Ramps)

Main Street: SIENNA\_PKWY Cross Street: O\_NEILL\_DR Location: NE

ADA ID: RPRK211111130324 Ramp Type: Type 1 - Perpendicular Initial Pass/Fail: Pass Overall Compliance: No Severity Score: 26

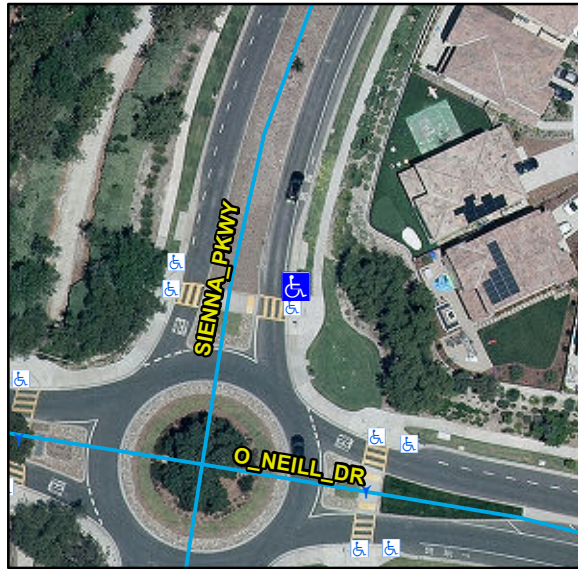
| Compliance | Description | Data | Compliance | Description | Data |
|---|---|---|---|---|---|
| No | Landing Cross Slope (%) | N/A | No | DWS Provided | No |
| No | Gutter Run Slope (%) | 8 | | Road Cross Slope (%) | N/A |

Remove & Replace Entire Ramp. Remove & Replace Gutter.
