# Access Compliance Report Public Rights-of-Way (Curb Ramps)

| Main Street: SIENNA_PKWY | | Cross Street: O_NEILL_DR | | Location: | NE |
| ADA ID: RPRK211111130740 | Ramp Type: Type 1 - Perpendicular | Initial Pass/Fail: Pass | Overall Compliance: No | Severity Score: | 0 |

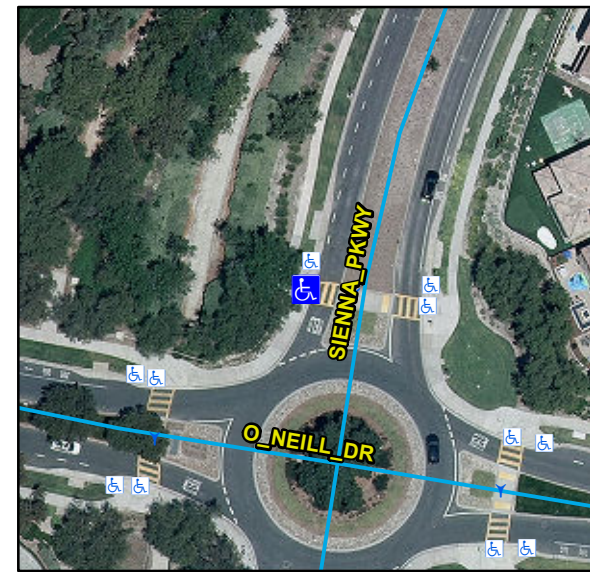
| Compliance | Description | Data | Compliance | Description | Data |
|---|---|---|---|---|---|
| N/A | Landing Present | Yes | No | Flare Type RT | |
| N/A | Landing Length (in) | 122 | | | Curbed1 |
| Yes | Gutter Ponding | No | No | Curb Slope | 7.1 |

Possible Solutions:

Remove & Replace Entire Ramp.

R304.2.2, R304.2.3, STD 1115

Total Cost: \$ 3080

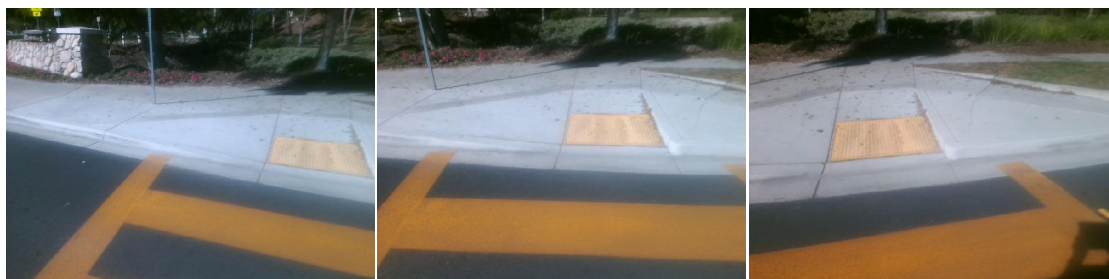
| Compliance | Description | Data | Compliance | Description | Data |
|---|---|---|---|---|---|
| N/A | Ramp Length (in) | 85 | N/A | Flare Type LT | |
| Yes | Ramp Width (in) | 50 | | | Sloped |
| Yes | Ramp Run Slope (%) | 7.8 | N/A | Flare Slope LT (%) | 6.5 |
| Yes | Ramp Cross Slope (%) | 0.4 | N/A | Flare Traversable LT | No |
| Yes | Overall Surface Condition: Acceptable | | Yes | Perp Joint Present | Yes |
