# Access Compliance Report Public Rights-of-Way (Curb Ramps)

Main Street: SIENNA\_PKWY Cross Street: O\_NEILL\_DR Location: NE

ADA ID: RPRK211111130949 Ramp Type: Type 1 - Perpendicular Initial Pass/Fail: Pass Overall Compliance: No Severity Score: 25

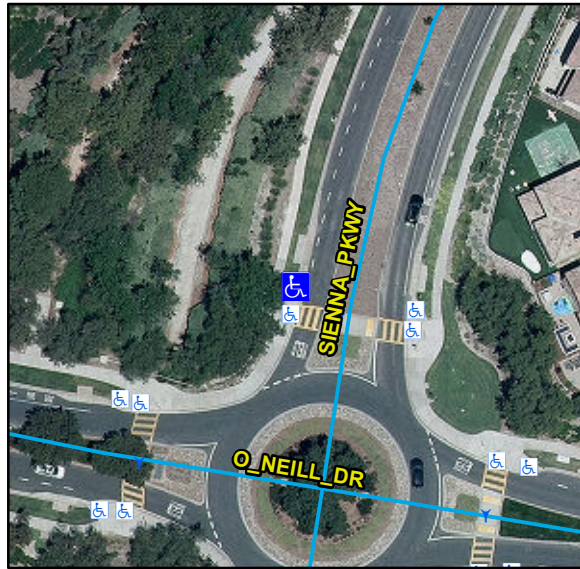
| Compliance | Description | Data | Compliance | Description | Data |
|---|---|---|---|---|---|
| No | Landing Width (in) | N/A | N/A | Flare Slope RT (%) | N/A |
| No | Landing Run Slope (%) | N/A | N/A | Flare Traversable RT | N/A |
| No | Landing Cross Slope (%) | N/A | No | DWS Provided | No |
| No | Gutter Run Slope (%) | 12.6 | | Road Cross Slope (%) | N/A |
| No | Gutter Cross Slope (%) | 3.9 | | | |

Remove & Replace Entire Ramp. Remove & Replace Gutter.
