# Access Compliance Report Public Rights-of-Way (Curb Ramps)

| Main Street: O_NEILL_DR | | Cross Street: SIENNA_PKWY | | Location: | NW |
| ADA ID: RPRK211111131139 | Ramp Type: Type 1 - Perpendicular | Initial Pass/Fail: Fail | Overall Compliance: No | Severity Score: | 15 |

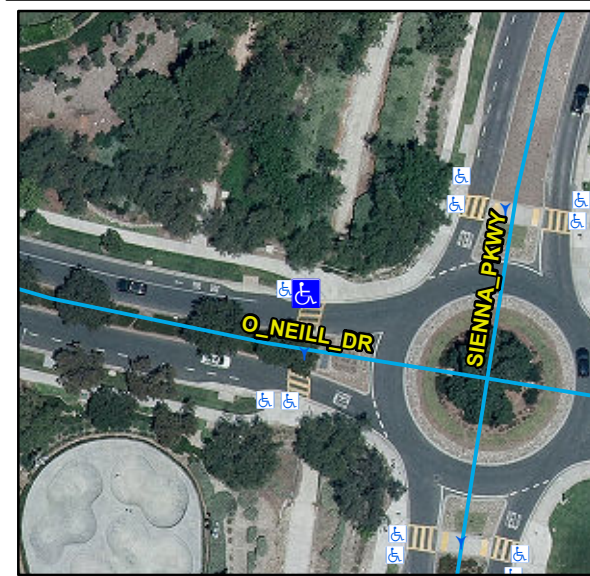
| Compliance | Description | Data | Compliance | Description | Data |
|---|---|---|---|---|---|
| No | Ramp Run Slope (%) | 8.8 | N/A | Flare Slope LT (%) | N/A |

Possible Solutions:

Remove & Replace Entire Ramp.

R304.2.2, STD 1115
