# Access Compliance Report Public Rights-of-Way (Curb Ramps)

Main Street: O\_NEILL\_DR Cross Street: SIENNA\_PKWY Location: NW

ADA ID: RPRK211111131245 Ramp Type: Type 1 - Perpendicular Initial Pass/Fail: Fail Overall Compliance: No Severity Score: 16

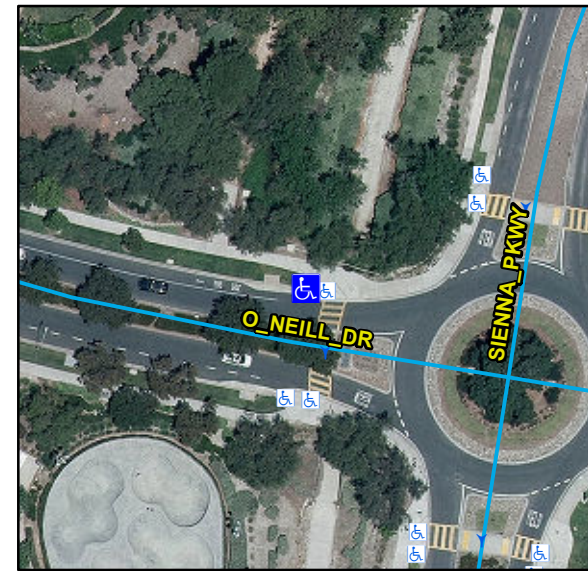
| Compliance | Description | Data | Compliance | Description | Data |
|---|---|---|---|---|---|
| No | Ramp Run Slope (%) | 9.8 | N/A | Flare Slope LT (%) | N/A |
| No | Ramp Cross Slope (%) | 3.5 | N/A | Flare Traversable LT | N/A |

Remove & Replace Entire Ramp.

R204.3, R304.2.2, R304.5.3, STD 1115
