# Access Compliance Report Public Rights-of-Way (Curb Ramps)

| Main Street: O_NEILL_DR | | Cross Street: SIENNA_PKWY | | Location: | NW |
| ADA ID: RPRK211111131529 | Ramp Type:Type 1 - Perpendicular | Initial Pass/Fail: Fail | Overall Compliance: No | Severity Score: | 16 |

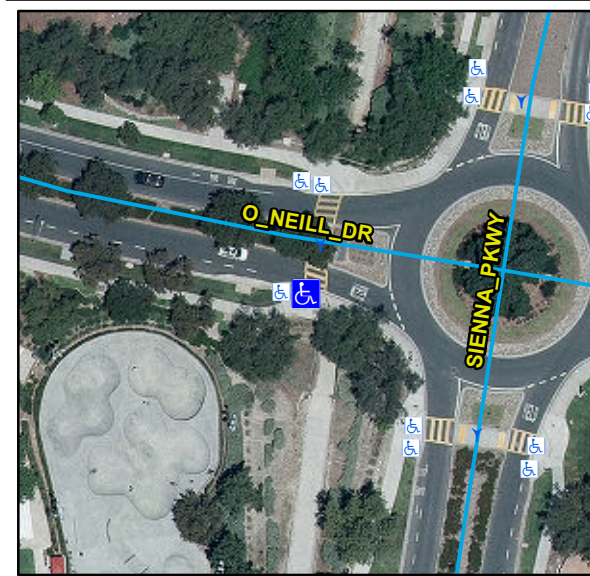
**R304.2.2, R304.5.3, STD 1115**

| Compliance | Description | Data | Compliance | Description | Data |
|---|---|---|---|---|---|
| No | Ramp Run Slope (%) | 8.5 | N/A | Flare Slope LT (%) | N/A |
| No | Ramp Cross Slope (%) | 2.6 | N/A | Flare Traversable LT | N/A |

**Remove & Replace Entire Ramp.**

Total Cost: \$ 3080
