# Access Compliance Report Public Rights-of-Way (Curb Ramps)

| Main Street: O_NEILL_DR | | Cross Street: SIENNA_PKWY | | Location: | NW |
| ADA ID: RPRK211111131634 | Ramp Type: Type 1 - Perpendicular | Initial Pass/Fail: Fail | Overall Compliance: No | Severity Score: | 30 |

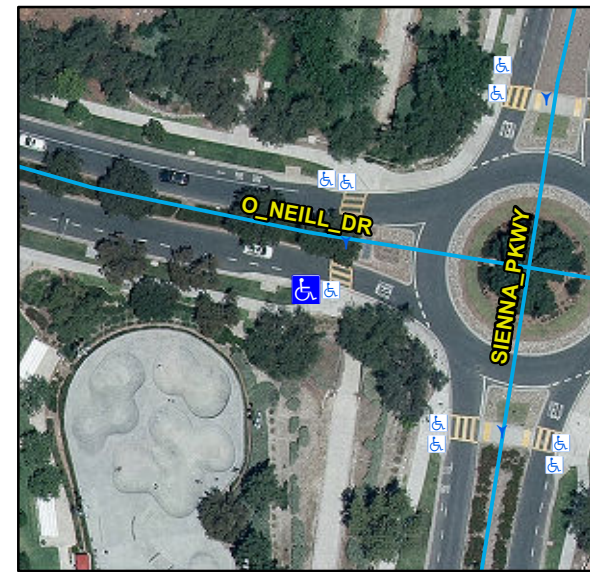
R304.2.2, R204.3, R304.5.3, R302.7.2, STD 1115

| Compliance | Description | Data | Compliance | Description | Data |
|---|---|---|---|---|---|
| No | Ramp Cross Slope (%) | 9.2 | N/A | Flare Traversable LT | N/A |
| No | Gutter Lip Height (in) | 0.25 | | Road Run Slope (%) | N/A |

Remove & Replace Entire Ramp.

Total Cost: \$ 3080
