# Access Compliance Report Public Rights-of-Way (Curb Ramps)

Main Street: N/A Cross Street: SIENNA\_PKWY Location: SW

ADA ID: RPRK211111132344 Ramp Type: Type 4 - Parallel Initial Pass/Fail: Fail Overall Compliance: No Severity Score: 5

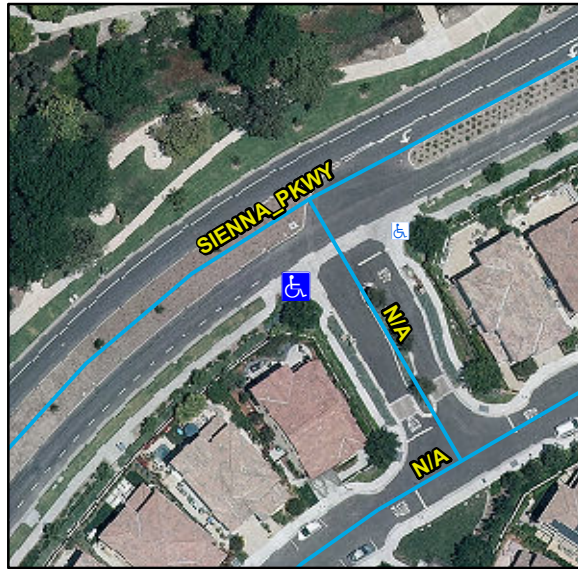
| Compliance | Description | Data | Compliance | Description | Data |
|---|---|---|---|---|---|
| No | Ramp Width LT (in) | 46 | No | Ramp Width RT (in) | 46 |
| No | Ramp Cross Slope LT (%) | 3.7 | Yes | Ramp Cross Slope RT (%) | 0.5 |

**Remove & Replace Curb Ramp With Two New Directional Ramps or Equivalent.**

**R304.5.1, R304.5.3, STD 1115**
