# Access Compliance Report Public Rights-of-Way (Curb Ramps)

Main Street: SIENNA\_PKWY Cross Street: N/A Location: SE

ADA ID: RPRK211111132616 Ramp Type: Type 4 - Parallel Initial Pass/Fail: Fail Overall Compliance: No Severity Score: 4

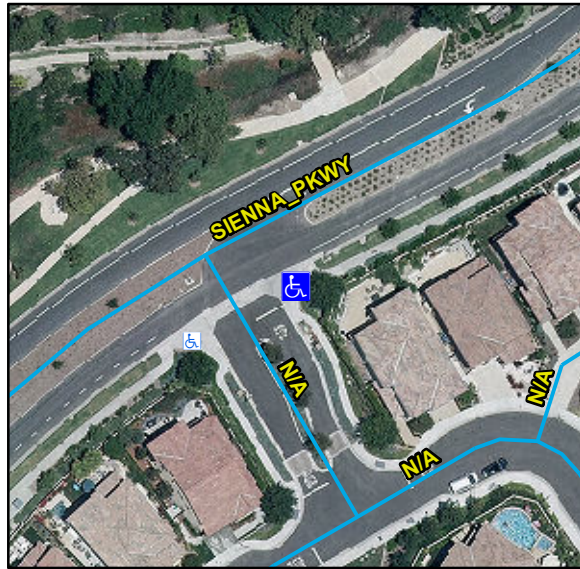
| Compliance | Description | Data | Compliance | Description | Data |
|---|---|---|---|---|---|
| No | Ramp Width LT (in) | 47 | No | Ramp Width RT (in) | 47 |

**Remove & Replace Curb Ramp With Two New Directional Ramps or Equivalent.**

R304.5.1, STD 1115
