# Access Compliance Report Public Rights-of-Way (Curb Ramps)

| Main Street: SIENNA_PKWY | | Cross Street: S_SELLAS_RD | | Location: | SW |
| ADA ID: RPRK211111133116 | Ramp Type: Type 1 - Perpendicular | Initial Pass/Fail: Fail | Overall Compliance: No | Severity Score: | 15 |

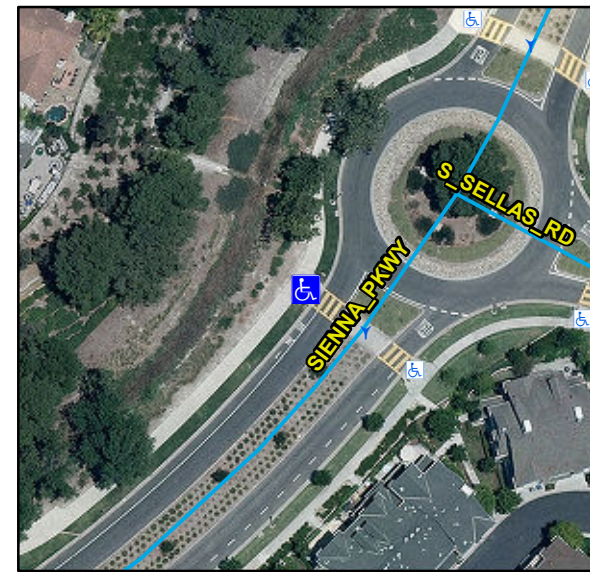
R204.3, R304.2.2, STD 1115

| Compliance | Description | Data | Compliance | Description | Data |
|---|---|---|---|---|---|
| No | Ramp Run Slope (%) | 9.7 | N/A | Flare Slope LT (%) | N/A |

Remove & Replace Entire Ramp.

Total Cost: \$ 3080
