# Access Compliance Report Public Rights-of-Way (Curb Ramps)

| Main Street: SIENNA_PKWY | | Cross Street: S_SELLAS_RD | | Location: | NE |
| ADA ID: RPRK211111133323 | Ramp Type: Type 1 - Perpendicular | Initial Pass/Fail: Fail | Overall Compliance: No | Severity Score: | 16 |

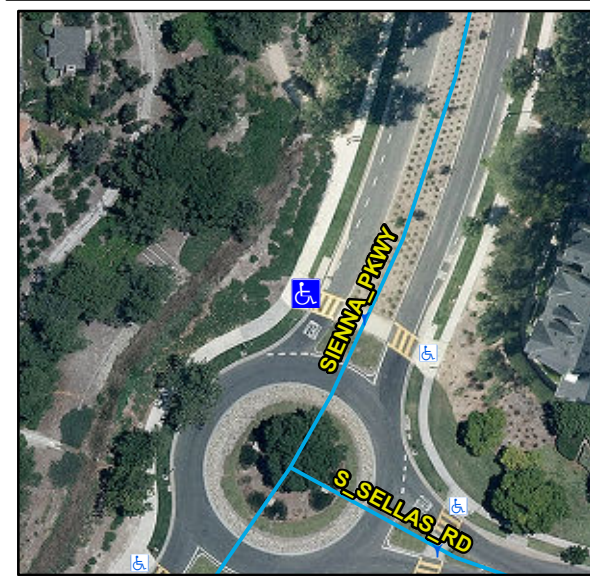
| Compliance | Description | Data | Compliance | Description | Data |
|---|---|---|---|---|---|
| No | Ramp Run Slope (%) | 8.4 | N/A | Flare Slope LT (%) | N/A |
| No | Ramp Cross Slope (%) | 2.3 | N/A | Flare Traversable LT | N/A |

**Remove & Replace Entire Ramp.**

**R304.2.2, R204.3, R304.5.3, STD 1115**
