# Access Compliance Report Public Rights-of-Way (Curb Ramps)

Main Street: SIENNA\_PKWY Cross Street: S\_SELLAS\_RD Location: NE

ADA ID: RPRK211111133709 Ramp Type: Type 1 - Perpendicular Initial Pass/Fail: Fail Overall Compliance: No Severity Score: 15

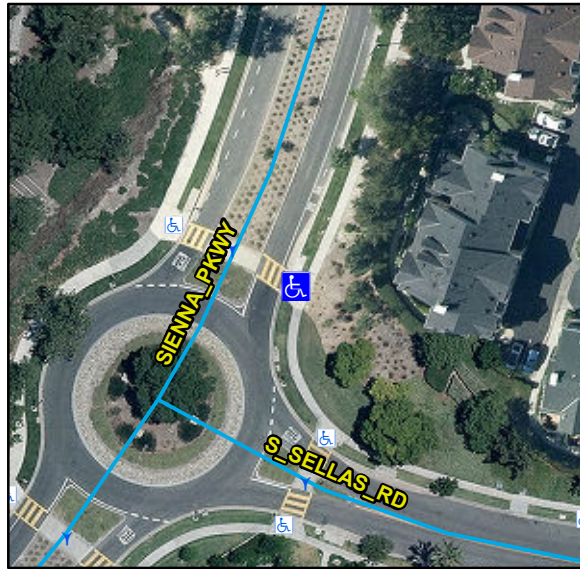
| Compliance | Description | Data | Compliance | Description | Data |
|---|---|---|---|---|---|
| No | Ramp Run Slope (%) | 10.2 | N/A | Flare Slope LT (%) | N/A |
| N/A | Gutter Ponding | N/A | No | Curb Slope | 10.1 |

Remove & Replace Entire Ramp.

R304.2.2, R204.3, STD 1115
