# Access Compliance Report Public Rights-of-Way (Curb Ramps)

Main Street: SIENNA\_PKWY Cross Street: S\_SELLAS\_RD Location: SE

ADA ID: RPRK211111133814 Ramp Type: Type 1 - Perpendicular Initial Pass/Fail: Fail Overall Compliance: No Severity Score: 15

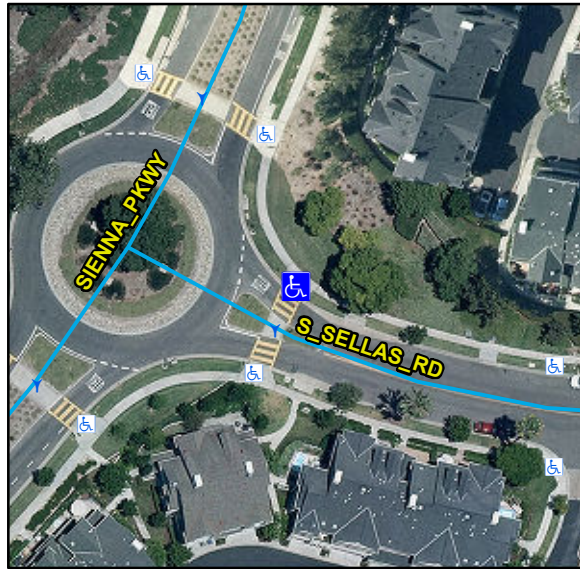
| Compliance | Description | Data | Compliance | Description | Data |
|---|---|---|---|---|---|
| No | Ramp Run Slope (%) | 11.1 | N/A | Flare Slope LT (%) | N/A |

Remove & Replace Entire Ramp.

R304.2.2, R204.3, STD 1115
