# Access Compliance Report Public Rights-of-Way (Curb Ramps)

| Main Street: SIENNA_PKWY | | Cross Street: S_SELLAS_RD | | Location: | SW |
| ADA ID: RPRK211111134206 | Ramp Type: Type 1 - Perpendicular | Initial Pass/Fail: Fail | Overall Compliance: No | Severity Score: | 15 |

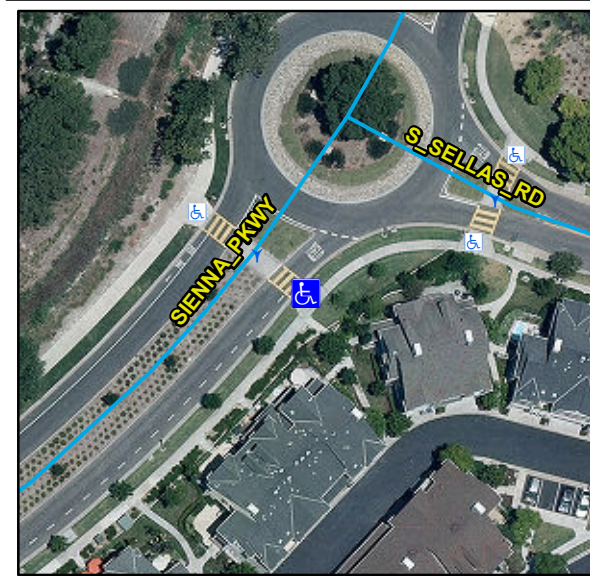
| Compliance | Description | Data | Compliance | Description | Data |
|---|---|---|---|---|---|
| <b>No</b> | Ramp Run Slope (%) | <b>9.1</b> | <b>N/A</b> | Flare Slope LT (%) | <b>N/A</b> |

Possible Solutions:  
**Remove & Replace Entire Ramp.**

OC Std/PROW:  
**R204.3, R304.2.2, STD 1115**

Total Cost: \$ **3080**
