# Access Compliance Report Public Rights-of-Way (Curb Ramps)

Main Street: ZINNIA\_ST Cross Street: SIENNA\_PKWY Location: SE

ADA ID: RPRK211111134847 Ramp Type: Type 4 - Parallel Initial Pass/Fail: Fail Overall Compliance: No Severity Score: 15

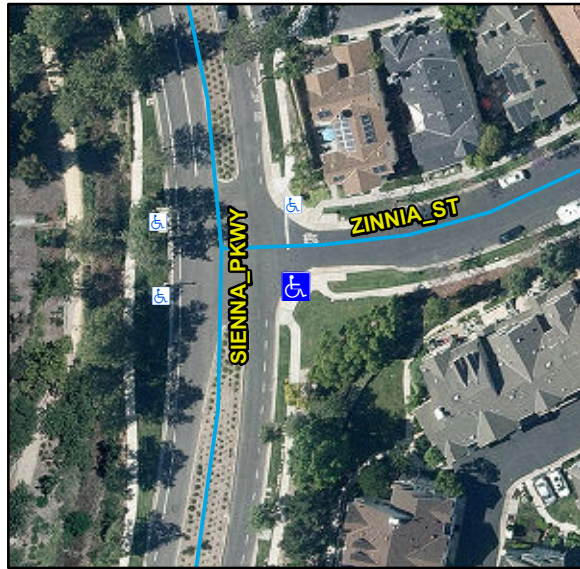
| Compliance | Description | Data | Compliance | Description | Data |
|---|---|---|---|---|---|
| Yes | Ramp Cross Slope LT (%) | 1.9 | No | Ramp Cross Slope RT (%) | 6.8 |

**Remove & Replace Curb Ramp With Two New Directional Ramps or Equivalent.**

**R204.3, R304.5.3, STD 1115**
