# Access Compliance Report Public Rights-of-Way (Curb Ramps)

Main Street: SIENNA\_PKWY Cross Street: ZINNIA\_ST Location: NE

ADA ID: RPRK211111135148 Ramp Type: Type 4 - Parallel Initial Pass/Fail: Pass Overall Compliance: No Severity Score: 25

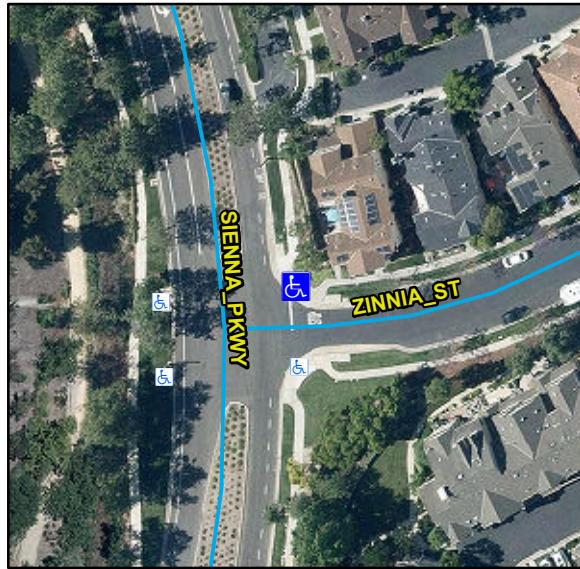
| Compliance | Description | Data | Compliance | Description | Data |
|---|---|---|---|---|---|
| N/A | Landing Present | No | No | DWS Provided | No |
| No | Landing Width (in) | N/A | N/A | DWS Length (in) | N/A |
| No | Landing Run Slope (%) | N/A | N/A | DWS Full Width | N/A |
| No | Landing Cross Slope (%) | N/A | | DWS Offset Type | N/A |
| No | Gutter Run Slope (%) | 6.6 | | Road Cross Slope (%) | 0.7 |

**Remove & Replace Curb Ramp With Two New Directional Ramps or Equivalent. Remove & Replace Gutter.**

**R204.3, R304.2.1, R304.2.2-Perp, R304.3.2-Para, R304.5.3, R305, R304.5.4, STD 1115**
