# Access Compliance Report Public Rights-of-Way (Curb Ramps)

| Main Street: SIENNA_PKWY | | Cross Street: ZINNIA_ST | | Location: | NW |
| ADA ID: RPRK211111135437 | Ramp Type: Type 1 - Perpendicular | Initial Pass/Fail: Fail | Overall Compliance: No | Severity Score: | 15 |

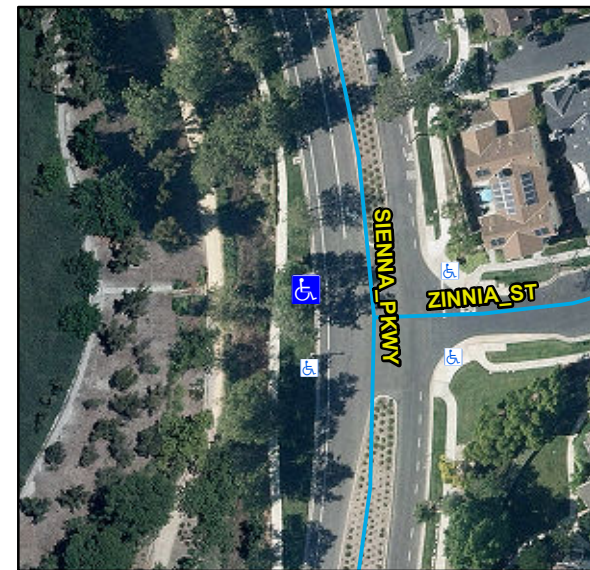
| Compliance | Description | Data | Compliance | Description | Data |
|---|---|---|---|---|---|
| No | Ramp Run Slope (%) | 10.4 | N/A | Flare Slope LT (%) | N/A |
| N/A | Gutter Ponding | N/A | No | Curb Slope | 17.4 |

**Remove & Replace Entire Ramp.**

**R304.2.2, R204.3, STD 1115**
