# Access Compliance Report Public Rights-of-Way (Curb Ramps)

| Main Street: GILLY_FLOWER_ST | | Cross Street: ZINNIA_ST | | Location: | S |
| ADA ID: RPRK211111140237 | Ramp Type: Type 4 - Parallel | Initial Pass/Fail: Fail | Overall Compliance: No | Severity Score: | 15 |

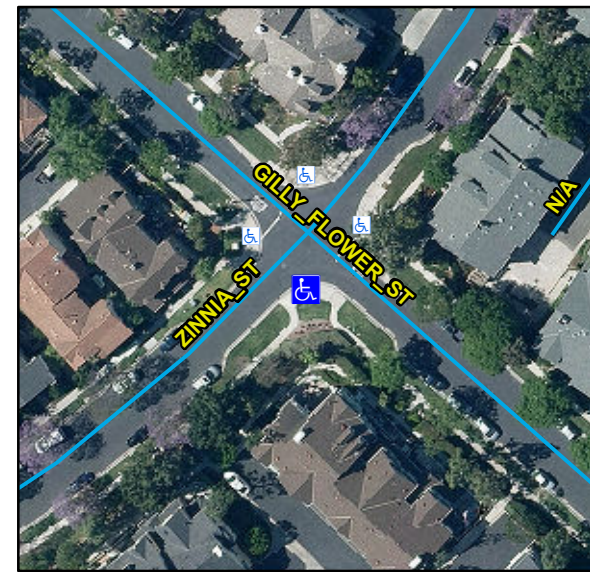
| Compliance | Description | Data | Compliance | Description | Data |
|---|---|---|---|---|---|
| No | Ramp Cross Slope LT (%) | 5.8 | No | Ramp Cross Slope RT (%) | 5 |
| N/A | Gutter Ponding | N/A | No | Curb Slope | 11.8 |

**Remove & Replace Curb Ramp With Two New Directional Ramps or Equivalent.**

**R304.2.2, R204.3, R304.5.3, STD 1115**

Total Cost: \$ 4000
