# Access Compliance Report Public Rights-of-Way (Curb Ramps)

Main Street: ZINNIA\_ST Cross Street: GILLY\_FLOWER\_ST Location: SE

ADA ID: RPRK211111140620 Ramp Type: Type 4 - Parallel Initial Pass/Fail: Fail Overall Compliance: No Severity Score: 2

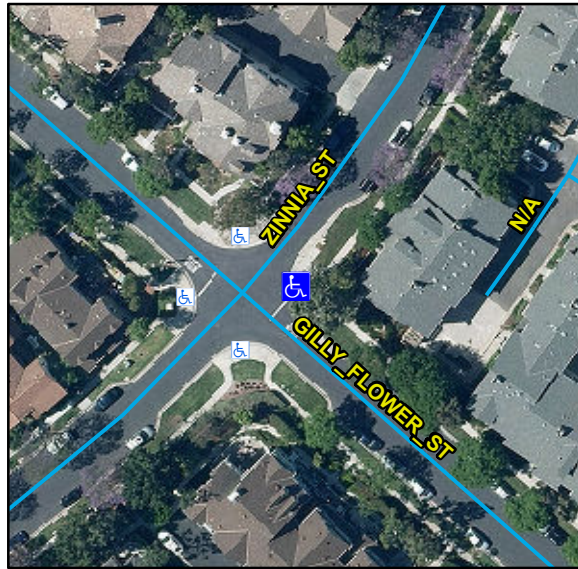
| Compliance | Description | Data | Compliance | Description | Data |
|---|---|---|---|---|---|
| No | Ramp Cross Slope LT (%) | 3.2 | No | Ramp Cross Slope RT (%) | 3.4 |

Remove & Replace Curb Ramp With Two New Directional Ramps or Equivalent.

R204.3, R304.5.3, STD 1115
