# Access Compliance Report Public Rights-of-Way (Curb Ramps)

| Main Street: GILLY_FLOWER_ST | | Cross Street: ZINNIA_ST | | Location: | NE |
| ADA ID: RPRK211111140824 | Ramp Type: Type 4 - Parallel | Initial Pass/Fail: Fail | Overall Compliance: No | Severity Score: | 2 |

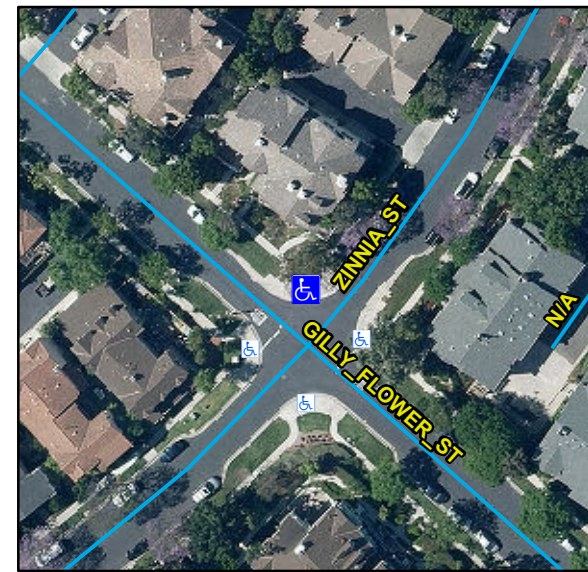
| Compliance | Description | Data | Compliance | Description | Data |
|---|---|---|---|---|---|
| No | Ramp Cross Slope LT (%) | 4 | Yes | Ramp Cross Slope RT (%) | 1.9 |

**Remove & Replace Curb Ramp With Two New Directional Ramps or Equivalent.**

**R204.3, R304.5.3, STD 1115**

Total Cost: \$ 4000

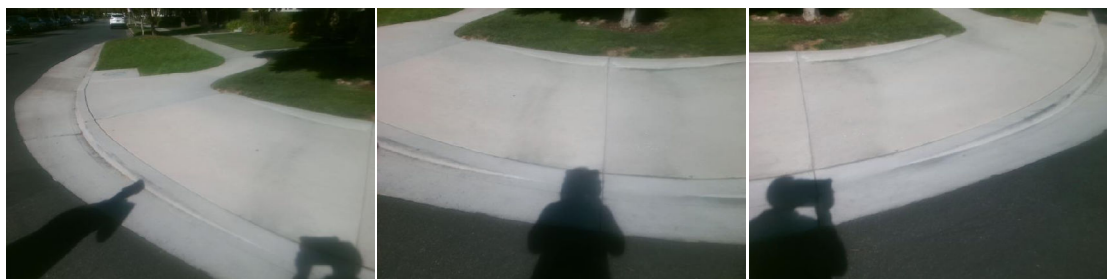
| Compliance | Description | Data | Compliance | Description | Data |
|---|---|---|---|---|---|
| N/A | Ramp Length LT (in) | 132 | N/A | Ramp Length RT (in) | 133 |
| Yes | Ramp Width LT (in) | 90 | Yes | Ramp Width RT (in) | 90 |
| Yes | Ramp Run Slope LT (%) | 4.8 | Yes | Ramp Run Slope RT (%) | 5.1 |
