# Access Compliance Report

## Public Rights-of-Way

### (Curb Ramps)

Main Street: ZINNIA\_ST Cross Street: GILLY\_FLOWER\_ST Location: W

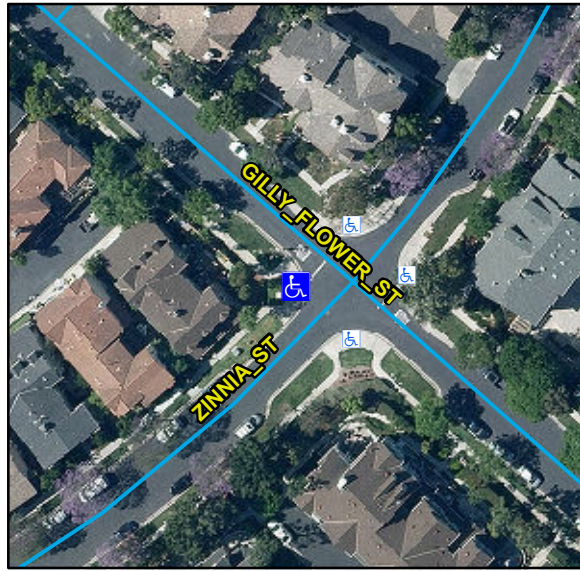
ADA ID: RPRK211111141018 Ramp Type: Type 4 - Parallel Initial Pass/Fail: Fail Overall Compliance: No Severity Score: 2

| Compliance | Description | Data | Compliance | Description | Data |
|---|---|---|---|---|---|
| Yes | Ramp Cross Slope LT (%) | 0.9 | No | Ramp Cross Slope RT (%) | 2.3 |

**Remove & Replace Curb Ramp With Two New Directional Ramps or Equivalent.**

**R204.3, R304.5.3, STD 1115**

Total Cost: \$ 4000
