# Access Compliance Report Public Rights-of-Way (Curb Ramps)

| Main Street: GILLY_FLOWER_ST | | Cross Street: S_DAISSY_ST | | Location: | SW |
| ADA ID: RPRK211111141406 | Ramp Type: Type 4 - Parallel | Initial Pass/Fail: Fail | Overall Compliance: No | Severity Score: | 2 |

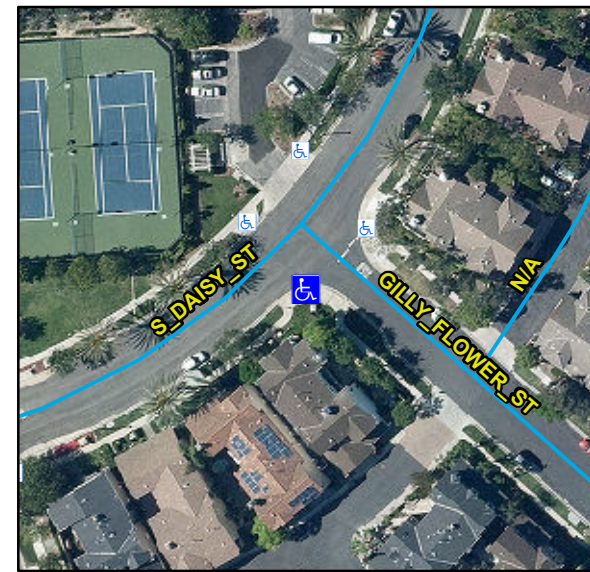
| Compliance | Description | Data | Compliance | Description | Data |
|---|---|---|---|---|---|
| No | Ramp Cross Slope LT (%) | 2.8 | No | Ramp Cross Slope RT (%) | 2.9 |

**Remove & Replace Curb Ramp With Two New Directional Ramps or Equivalent.**

**R204.3, R304.5.3, STD 1115**

Total Cost: \$ 4000
