# Access Compliance Report Public Rights-of-Way (Curb Ramps)

Main Street: S\_DAISSY\_ST Cross Street: GILLY\_FLOWER\_ST Location: NW

ADA ID: RPRK211111141944 Ramp Type:Type 1 - Perpendicular Initial Pass/Fail: Pass Overall Compliance: No Severity Score: 16

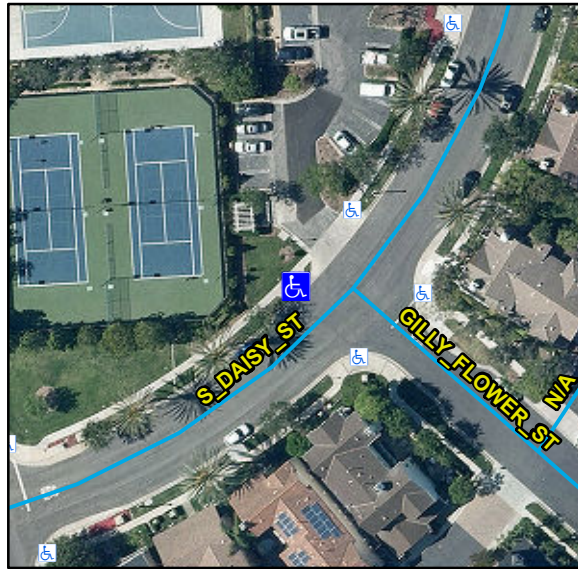
| Compliance | Description | Data | Compliance | Description | Data |
|---|---|---|---|---|---|
| No | Landing Run Slope (%) | 4.1 | N/A | Flare Traversable RT | Yes |
| No | Landing Cross Slope (%) | 2.4 | No | DWS Provided | No |
| Yes | Gutter Ponding | No | No | Curb Slope | 5.9 |
| No | Gutter Run Slope (%) | 7.9 | | Road Cross Slope (%) | N/A |

Remove & Replace Entire Ramp. Remove & Replace Gutter.
