# Access Compliance Report Public Rights-of-Way (Curb Ramps)

Main Street: AVENDALE\_BLV D Cross Street: ZINNIA\_ST Location: SE

ADA ID: RPRK211111165648 Ramp Type: Type 4 - Parallel Initial Pass/Fail: Fail Overall Compliance: No Severity Score: 2

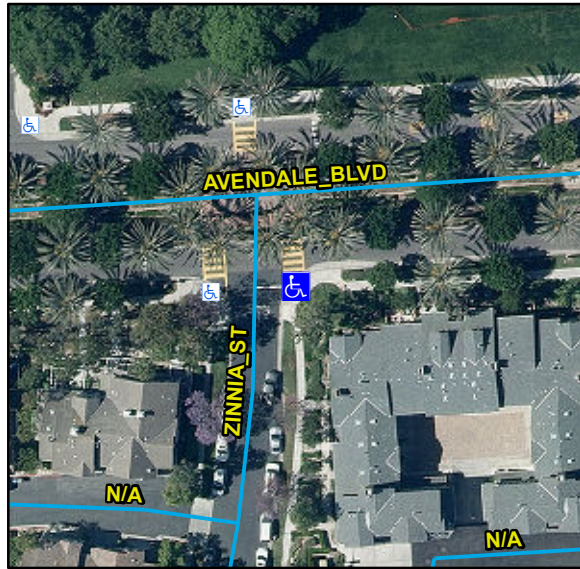
| Compliance | Description | Data | Compliance | Description | Data |
|---|---|---|---|---|---|
| Yes | Ramp Run Slope LT (%) | 6.7 | Yes | Ramp Run Slope RT (%) | 2 |
| No | Ramp Cross Slope LT (%) | 4.2 | No | Ramp Cross Slope RT (%) | 3.8 |

**Remove & Replace Curb Ramp With Two New Directional Ramps or Equivalent.**

**R204.3, R304.5.3, STD 1115**
